WT-1328

Operation

REDWING

Project 5.2

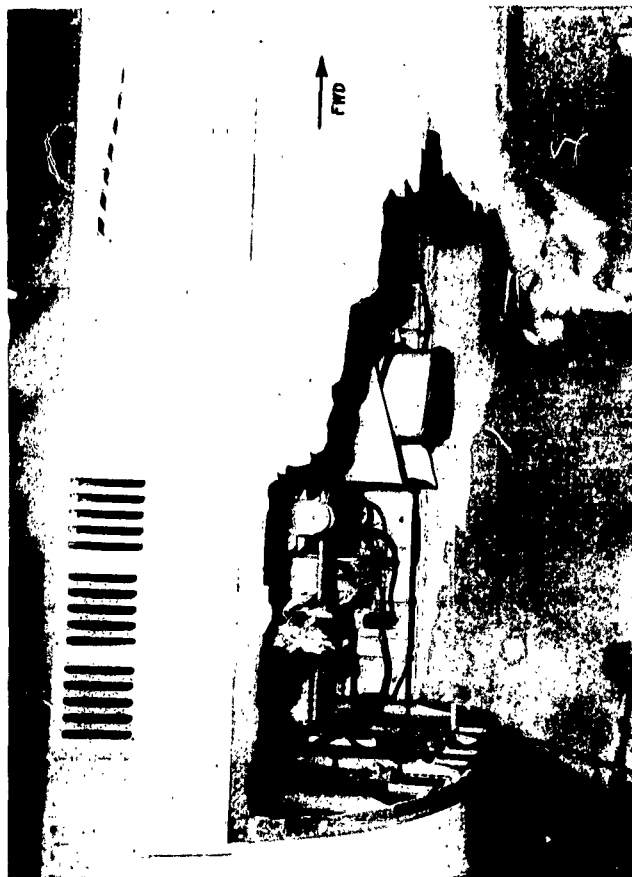
Figure 3.7 Damage photo, ECM radome, Shot Huron.

The ECM radome and bomb-bay doors were unshored for this shot as they were for Shot Tewa. The radome suffered a complete failure as a result of the overpressure (Figure 3.7). The forward panel of the lower aft left-hand bomb-bay door was buckled over approximately a two-foot length. There was visual evidence of damage to one door rib and probable damage to a second rib in this location. Also, slight permanent skin buckles occurred on the lower-left-forward door adjacent to the hinge support (Figure 3.6). No other damage was noted.

4. It is recommended that revisions be made to the ECM radome to increase its overpressure capability to be consistent with the basic overpressure capability of the B-52.
